Subject: Department of Natural Resources Washington Geological Survey,
School Seismic Safety Assessment Project, Contract No. AE 410 -
Seismic Evaluation for **Thorp School District**

School Buildings Evaluated in the Thorp School District

1.1 Building Description

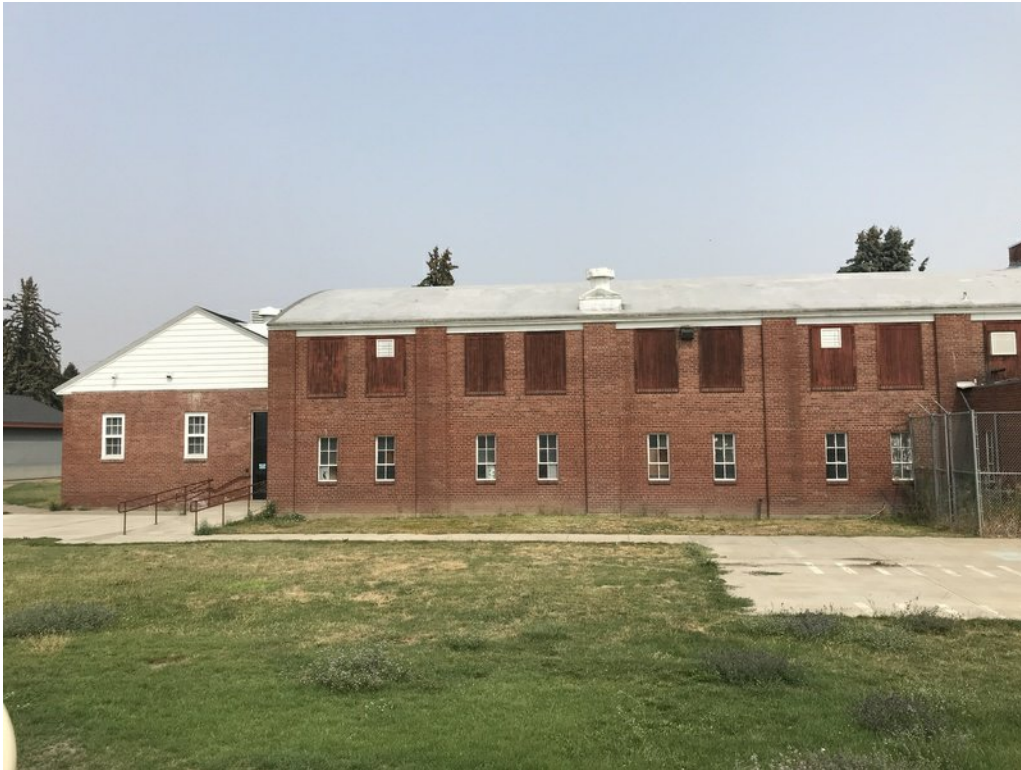
Figure 1-1. Thorp MS gym - west elevation

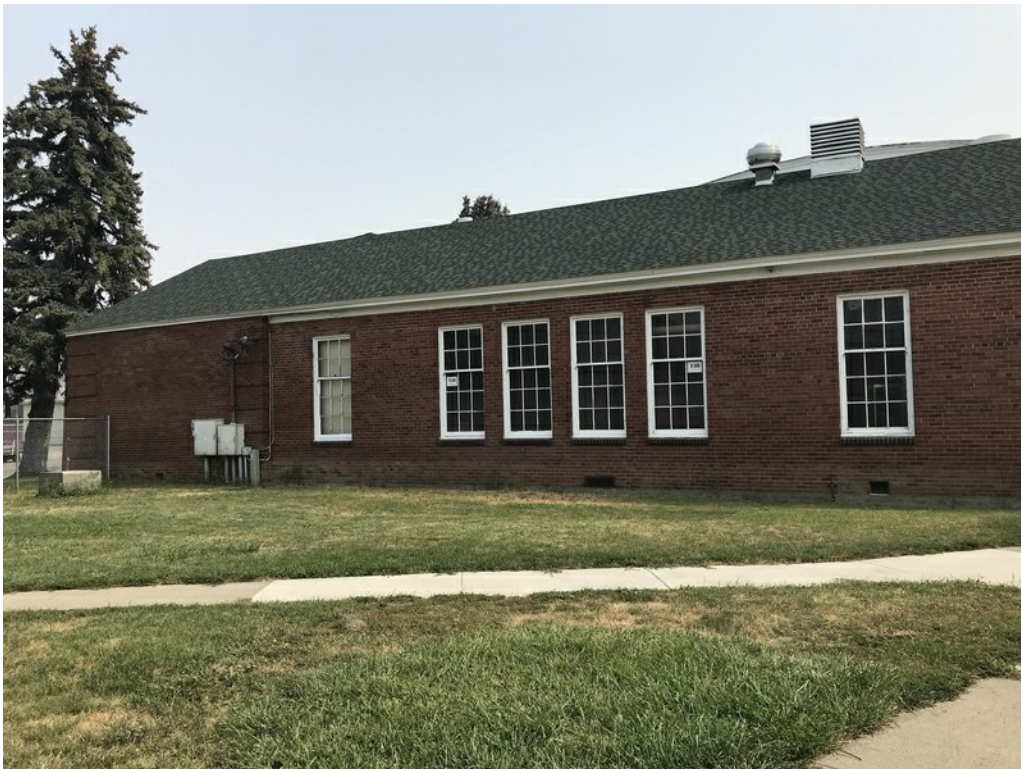
Figure 1-2. Thorp MS south elevation

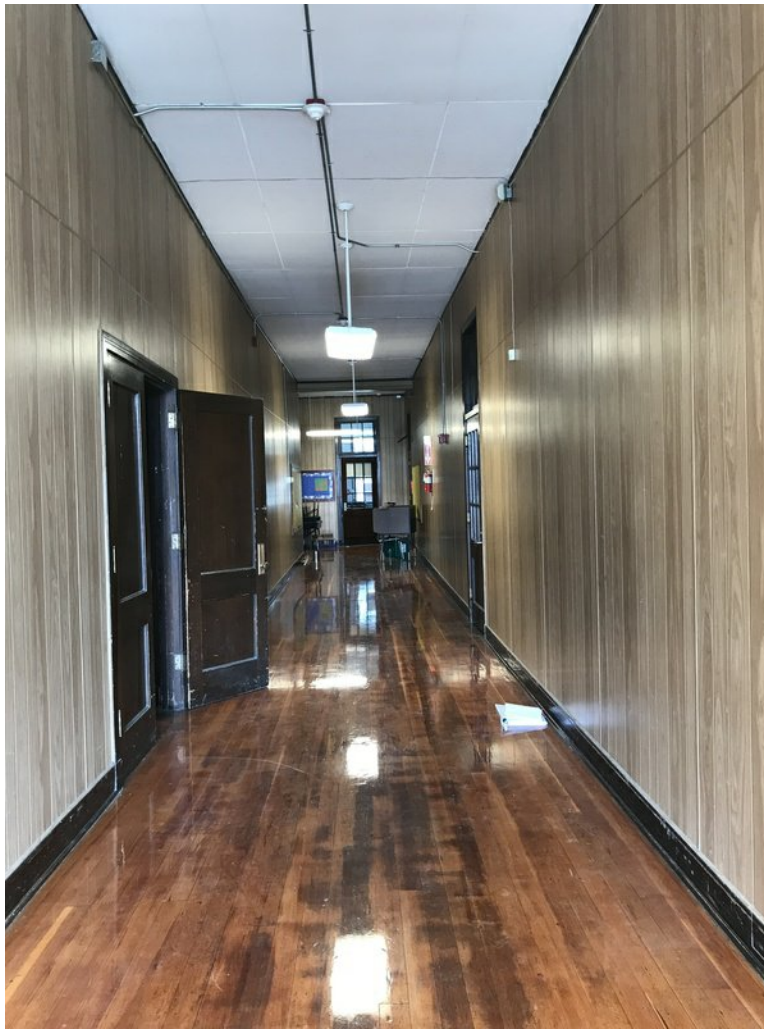
Figure 1-3. Thorp MS hall

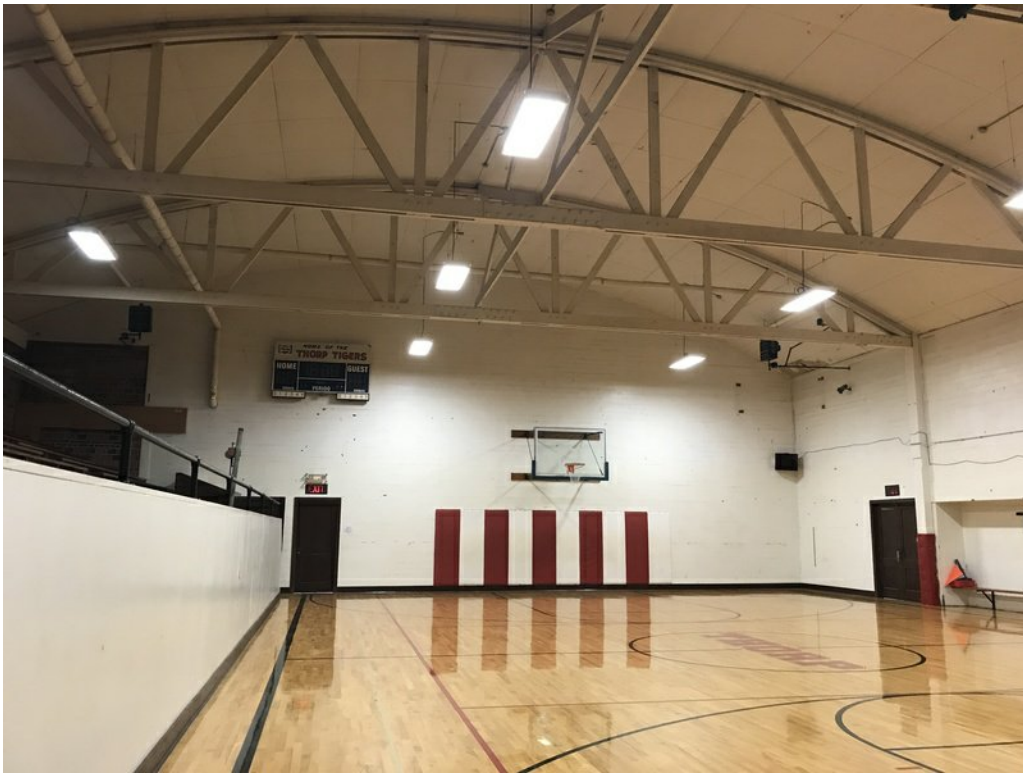
Figure 1-4. Thorp MS gym

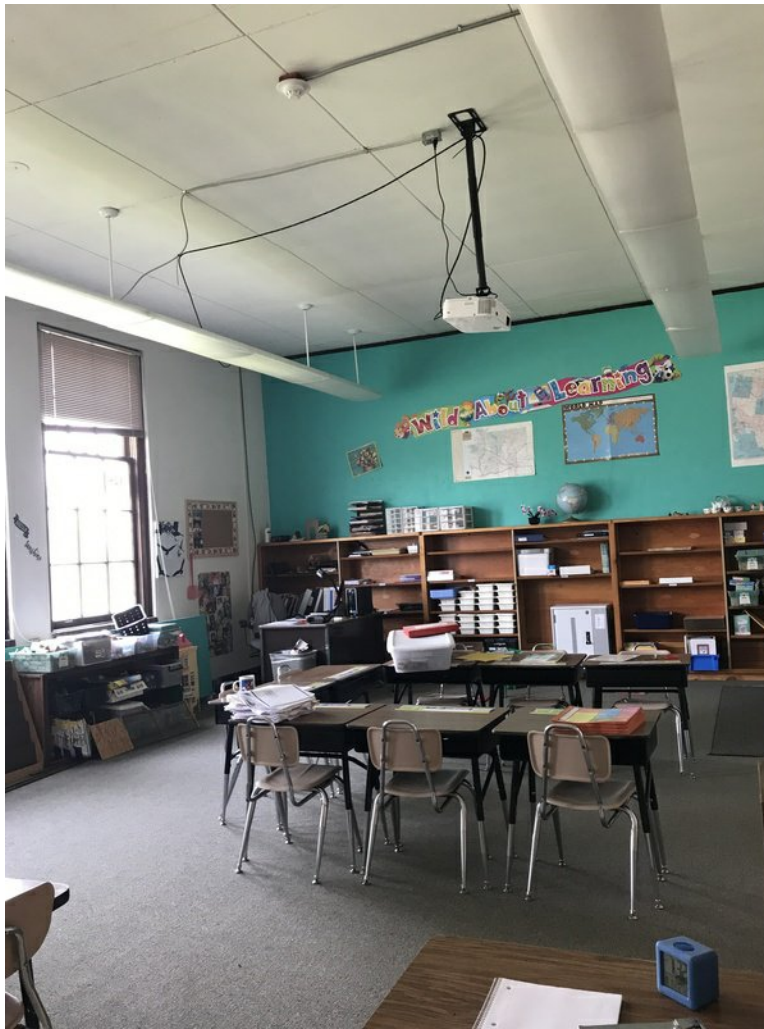
Figure 1-5. Thorp MS classroom

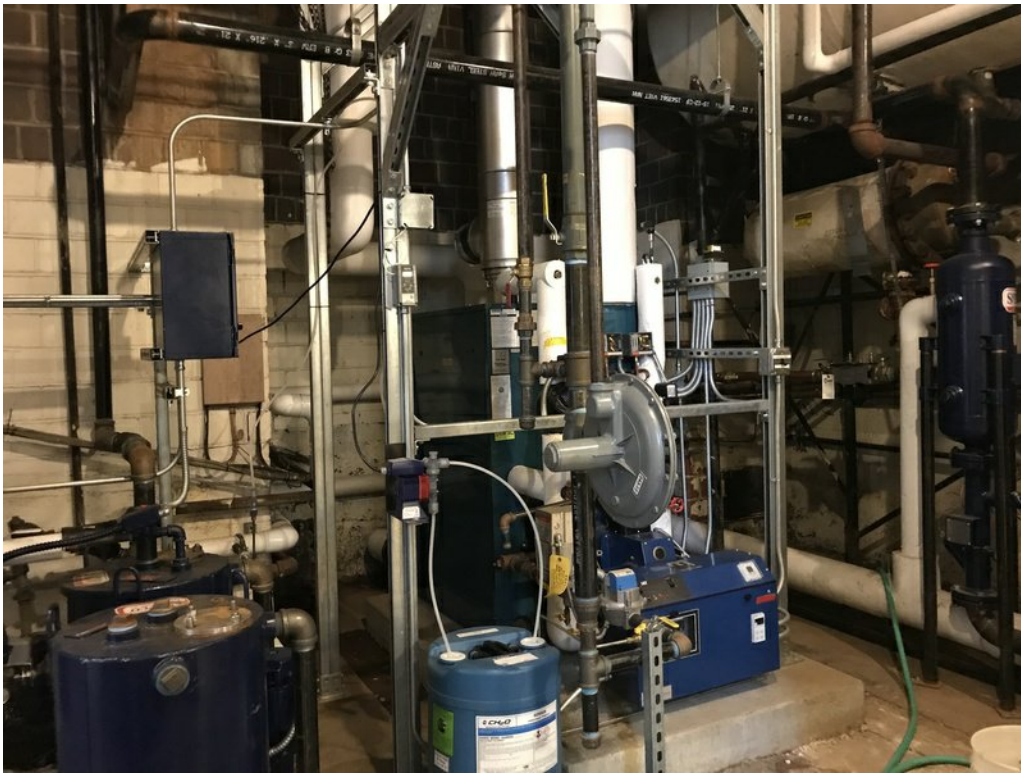
Figure 1-6. Thorp MS mech'l room

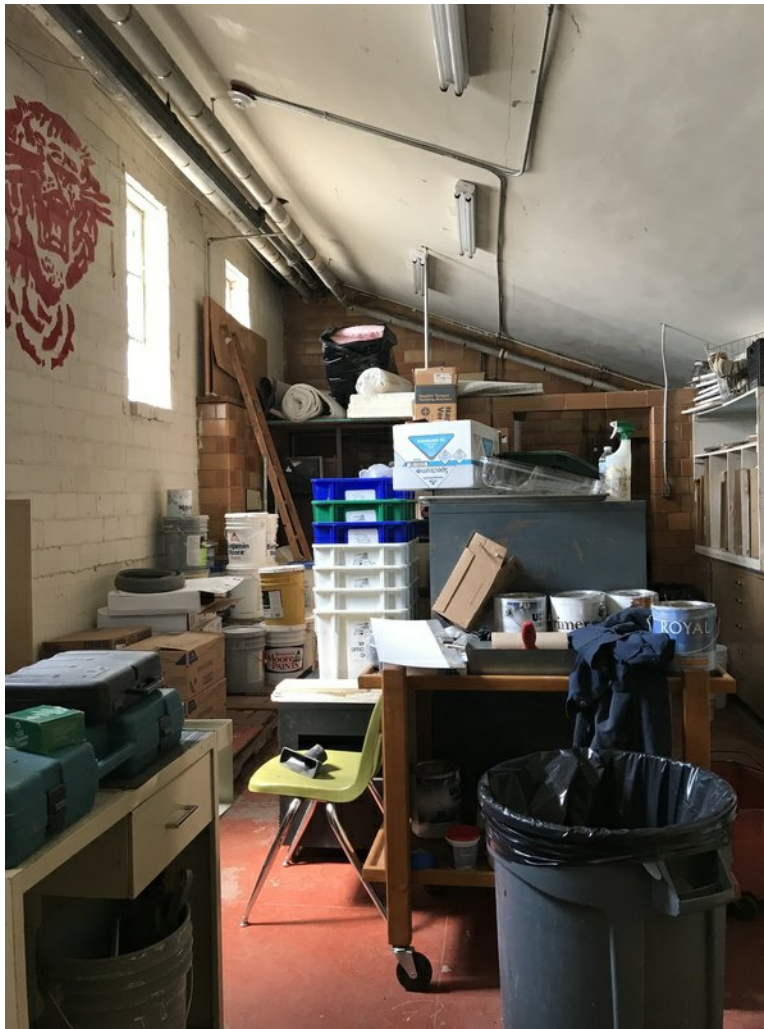
Figure 1-7. Thorp MS storage (old locker room)

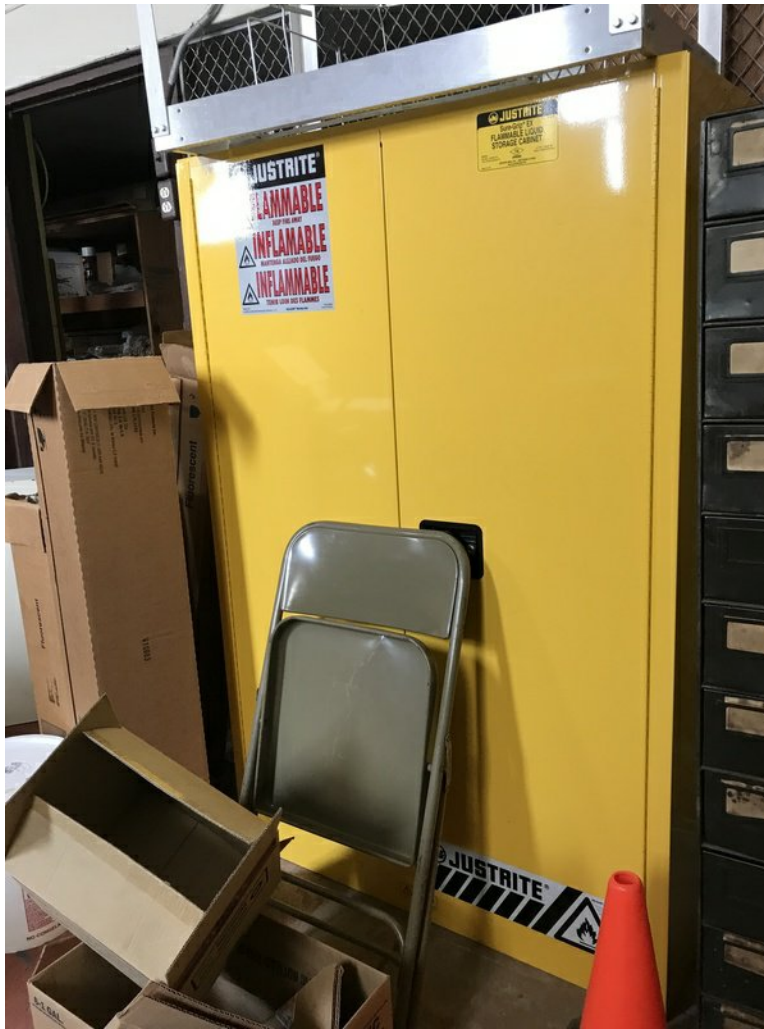
Figure 1-8. Thorp MS hazardous storage (old locker room)

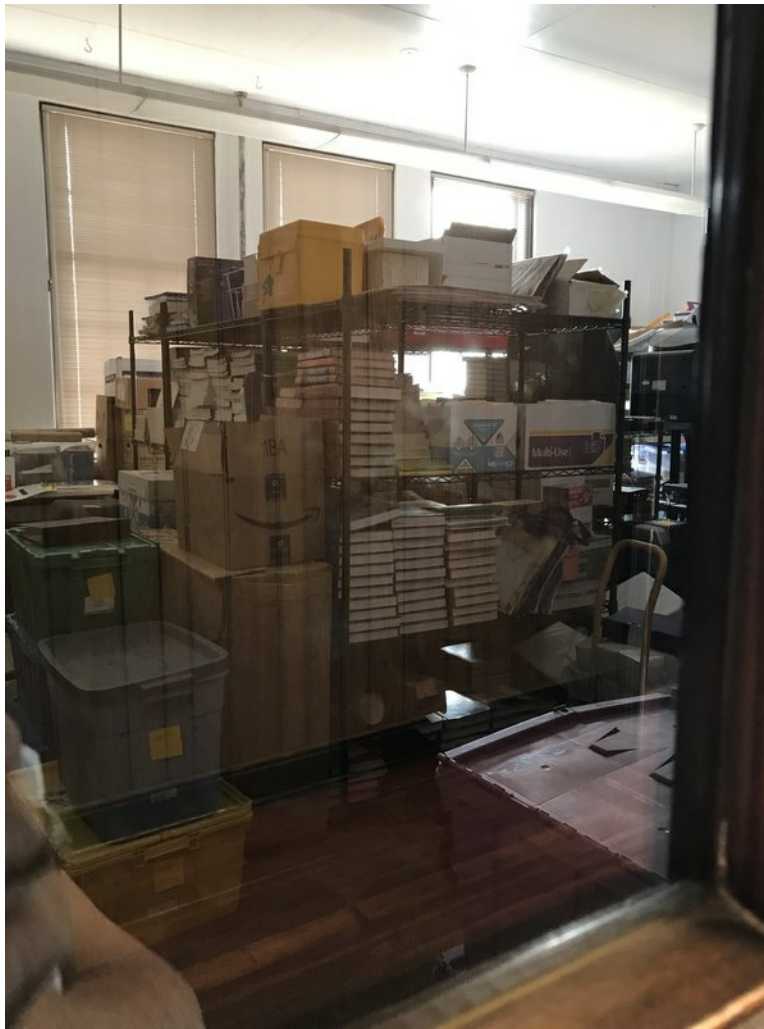
Figure 1-9. Thorp MS supply storage (temporary according to district personnel)

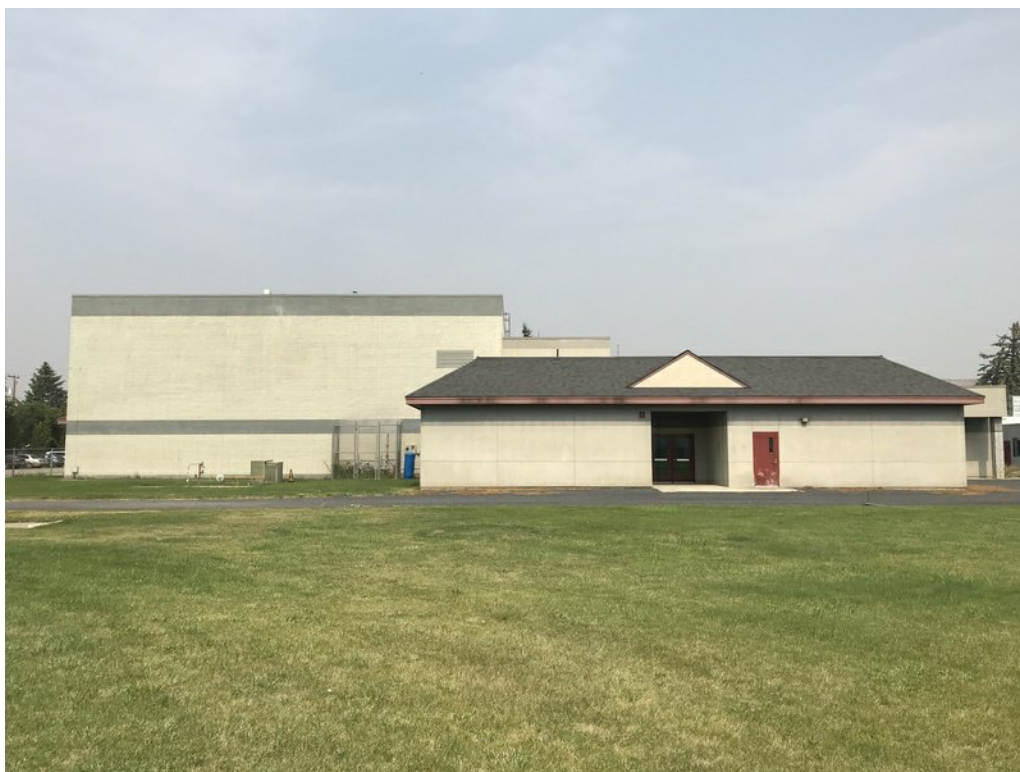
Figure 1-1. Thorp HS west elevation

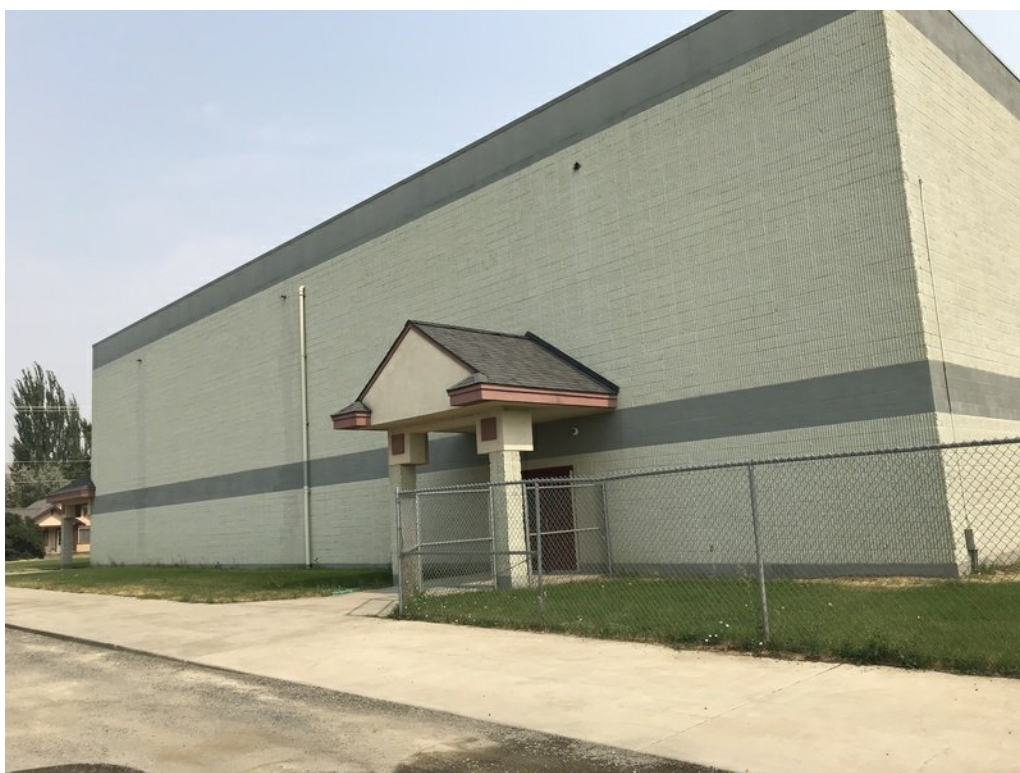
Figure 1-2. Thorp HS Gym north wall

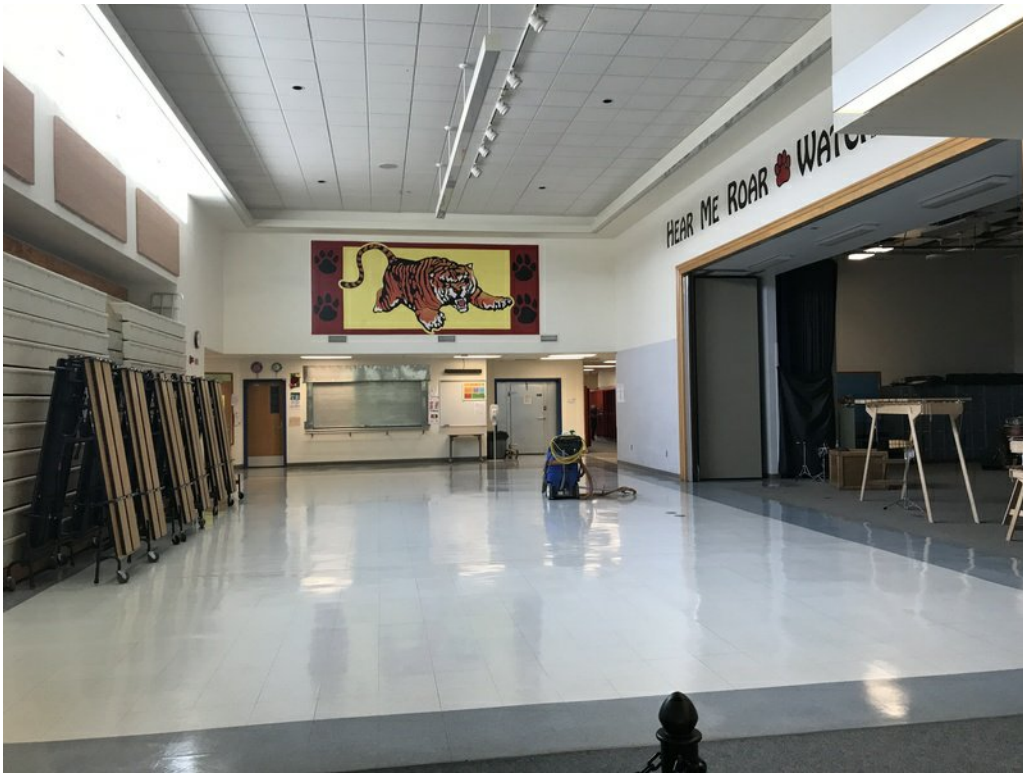
Figure 1-3. Thorp HS Commons

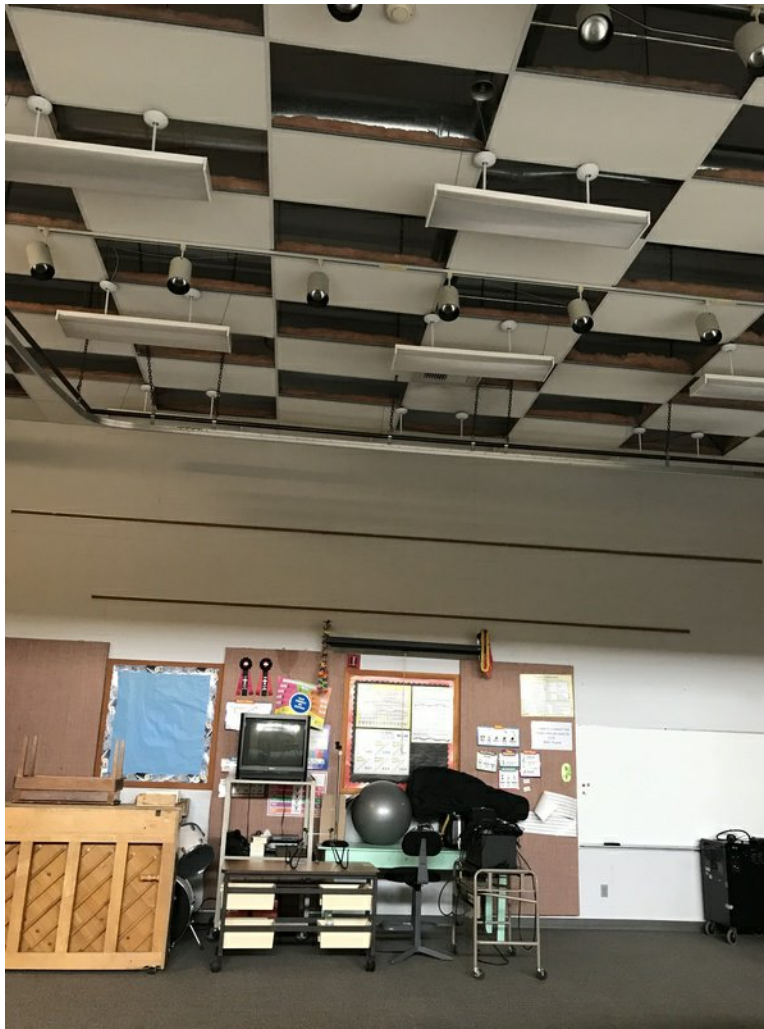
Figure 1-4. Thorp HS Commons -Band area ceiling

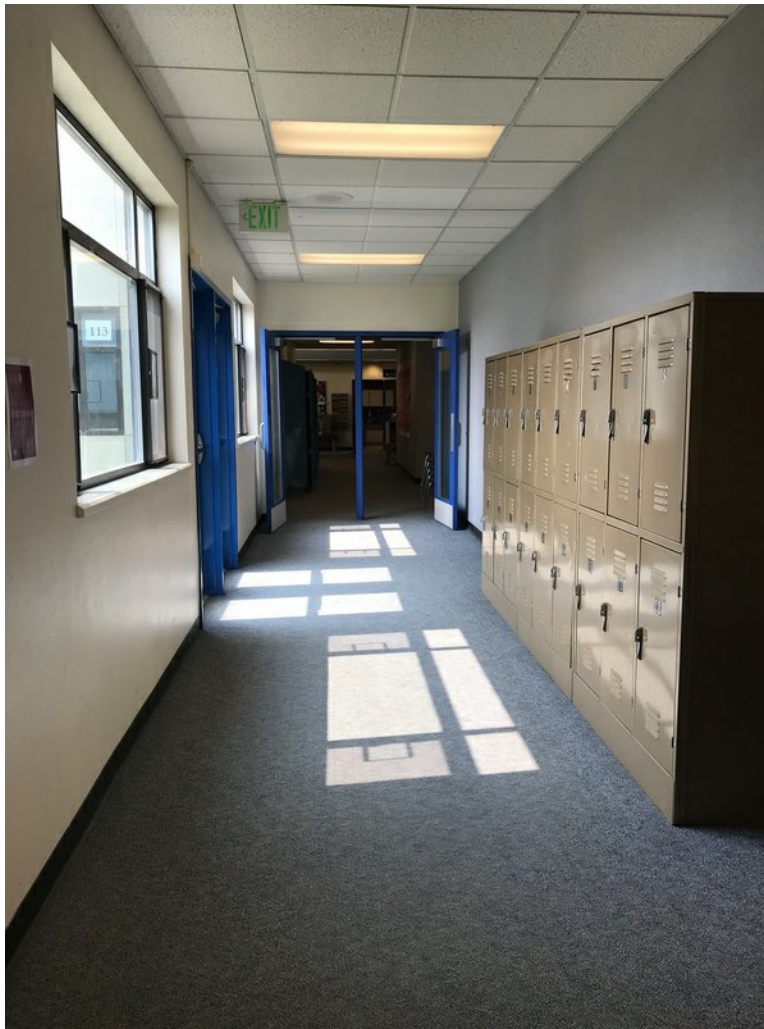
Figure 1-5. Thorp HS hallway

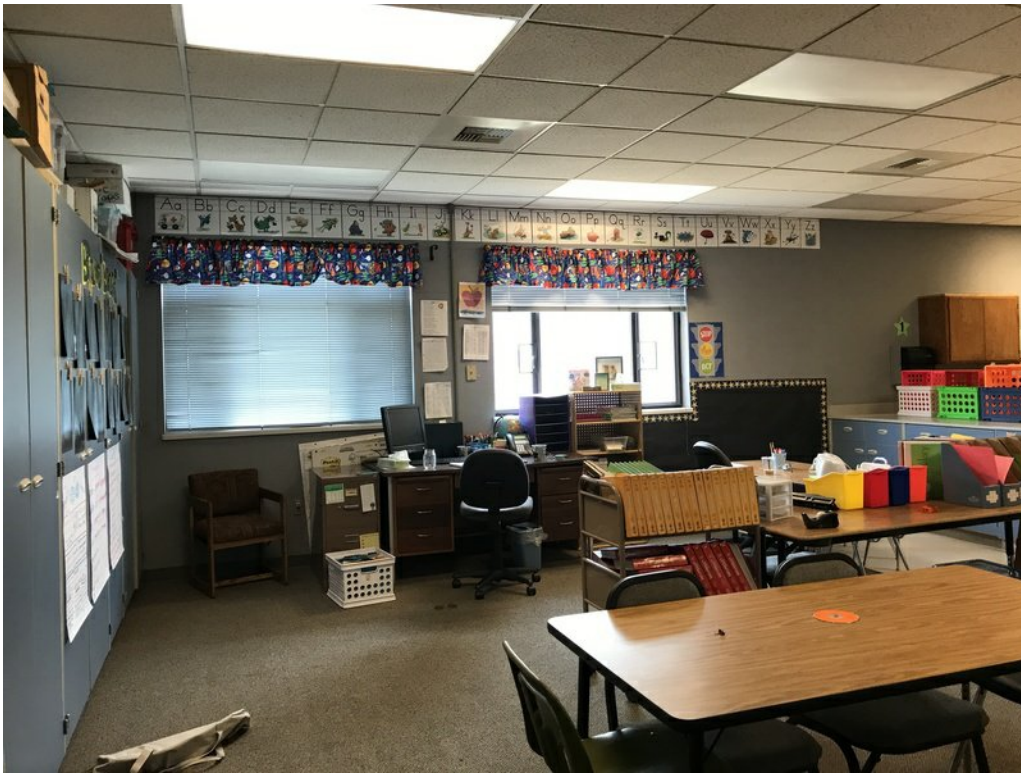
Figure 1-6. Thorp HS classroom

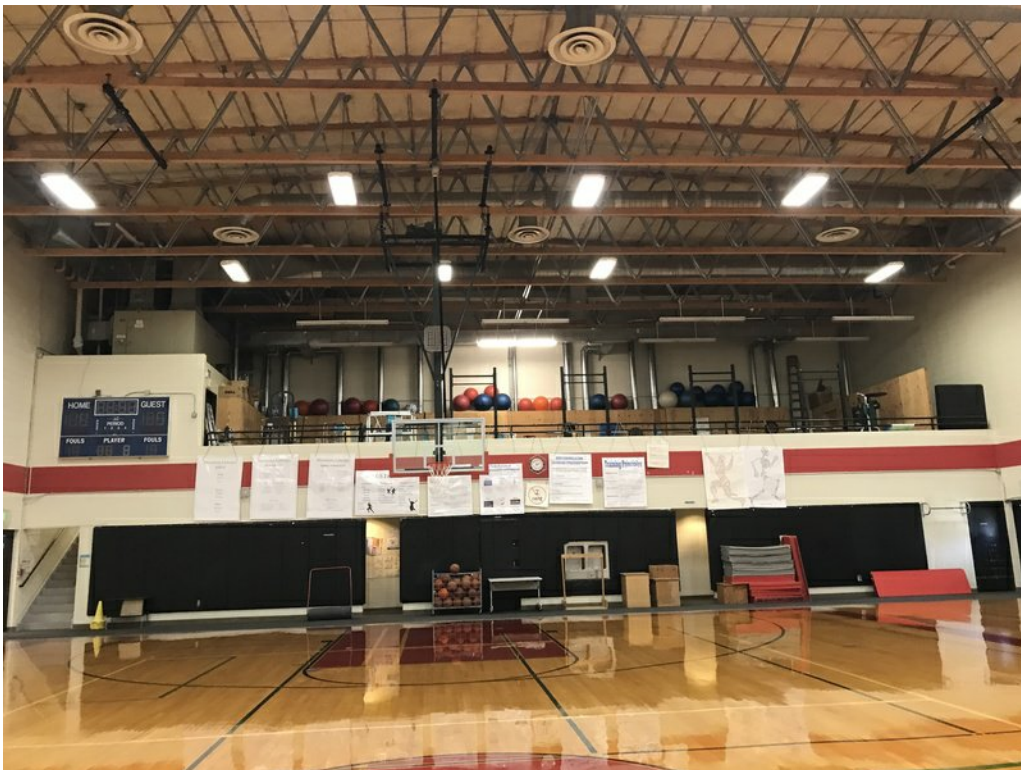
Figure 1-7. Thorp HS gym & mezzanine

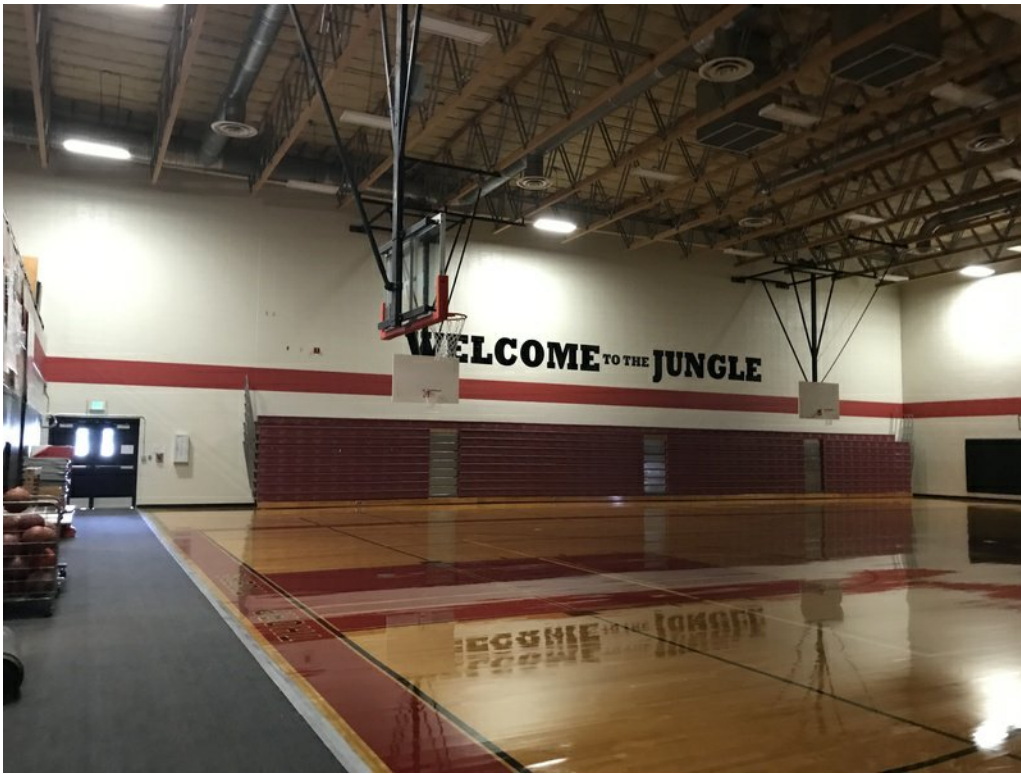
Figure 1-8. Thorp HS North wall (stack bond?)

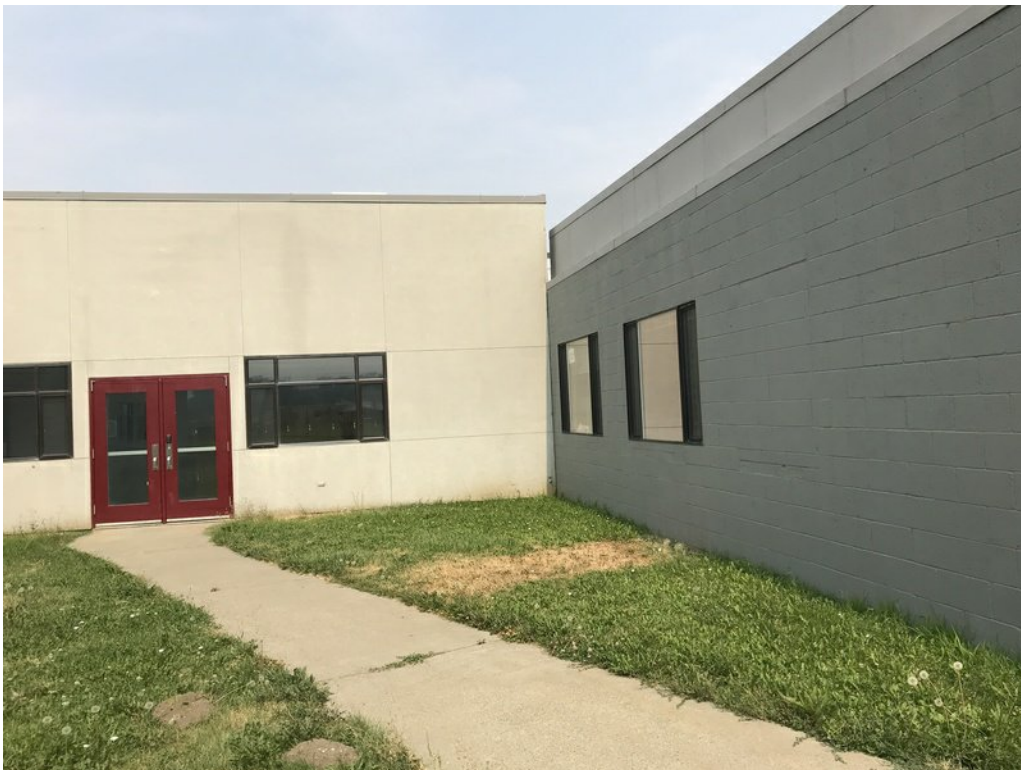
Figure 1-9. Thorp HS addition to 1950 construction
